Sandstone Discolouration & Effective Remedies

Discolouration in Natural Sandstone Units

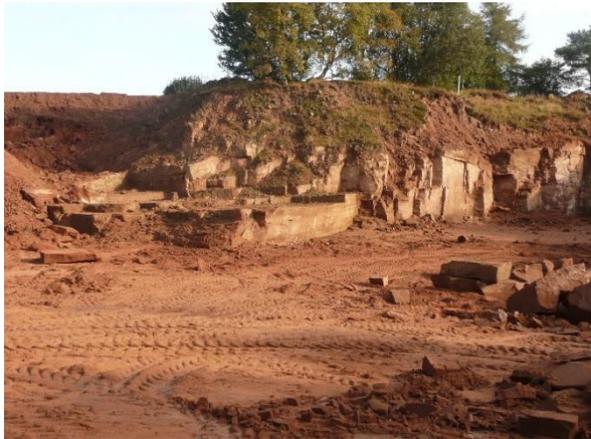
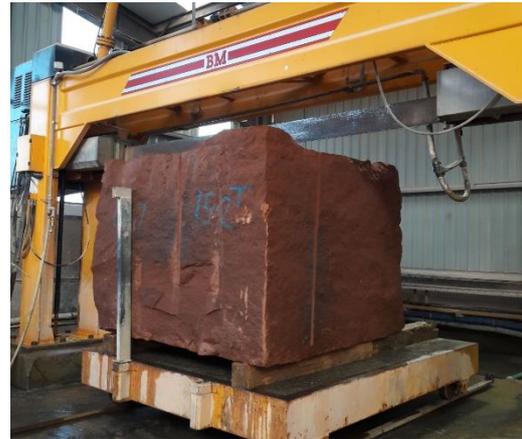
A typical quarry site and a screened quarry block being cut on a primary saw.

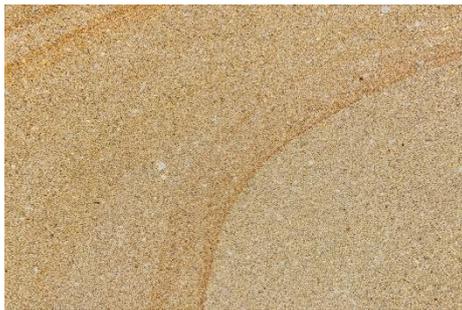
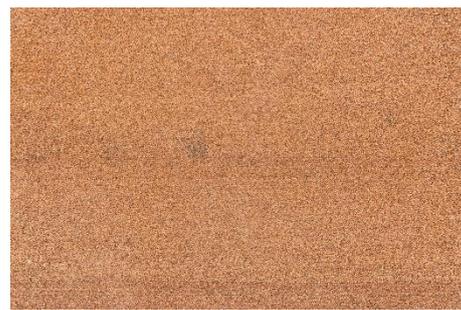
Some of the natural features found within British Sandstone.
(Left Hand Photo – Longridge Sandstone; Right Hand Photo – Corsehill Sandstone)

Due to the way in which sandstone is formed it is possible for different seams of materials to run through the stone. One example of this is orange banding within some sandstones that may be caused by the presence of iron oxide (this is very common in our Longridge sandstone but can also feature in other stones depending on the variations within the block).

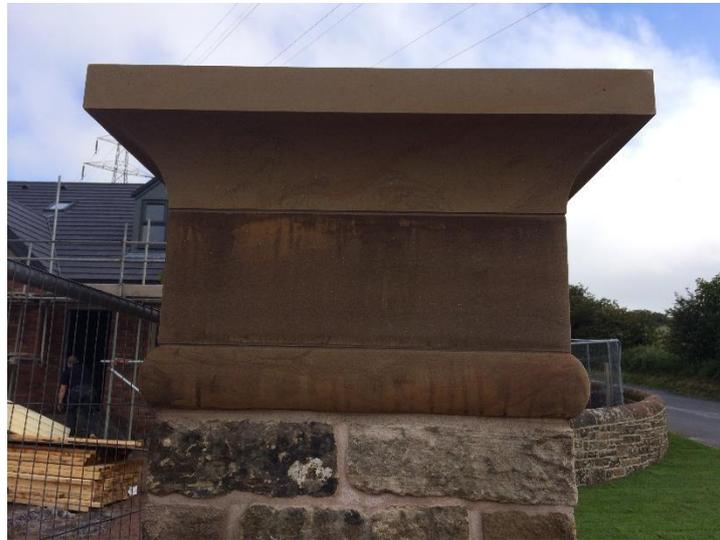
An untreated Buff Sandstone pillar cap that has darkened due to high levels of Manganese within the stone

While these minerals often give desirable features within the stones, too high a concentration of certain materials within sandstone can cause issues that need to be addressed; one of the most common issues faced by the natural stone industry as a whole is the discolouration of sandstone. At Cumbrian Stone we have found that if any discolouration does occur, it is normally isolated to a small number of stones across a project and normally involves the stone darkening quicker than would normally be expected. This can happen across all British sandstones, and is caused by a higher than normal concentration of manganese within the stone which oxidises after the stone has been

built. Unfortunately there is no way to detect this at the time of inspecting or cutting the sandstone block, and despite what assurances may be given it is impossible to offer a genuine guarantee against this.

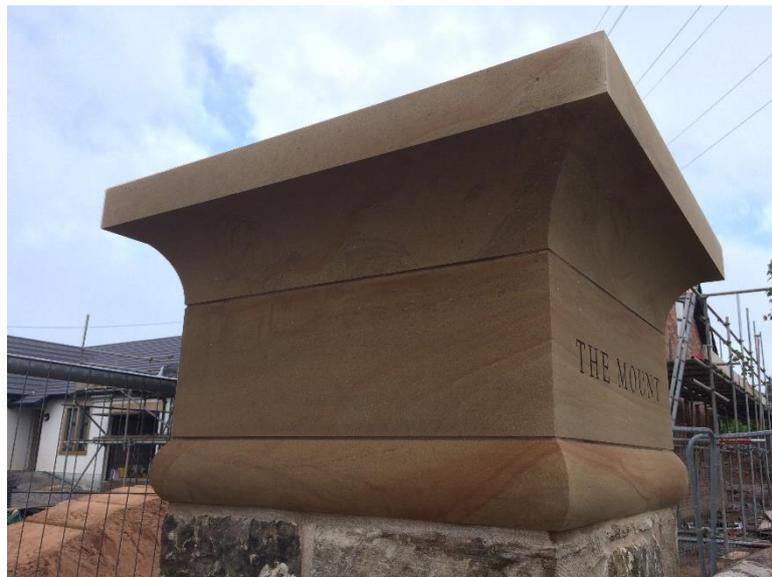
A Longridge Sandstone pillar cap following treatment where discolouration has occurred. (This is the same pillar cap as the discoloured pillar cap above).

Fortunately, at Cumbrian Stone we have developed a successful treatment that removes any discolouration from the face of the sandstone as well as preventing reoccurrence in the future. This involves a simple application of a chemical compound to the face of any discoloured stones which draws the manganese oxide to the surface and neutralises it, restoring the original appearance of the stone. This process has been successfully tested by our team on several projects across the UK allowing Cumbrian Stone to ensure that our customers are left with the finished appearance they desire.
